STRUCTURAL STABILITY ASSESSMENT
MORROW CCR IMPOUNDMENT

FORMER MORROW POWER PLANT
KALAMAZOO COUNTY, COMSTOCK TOWNSHIP,
MICHIGAN

MAY 2026

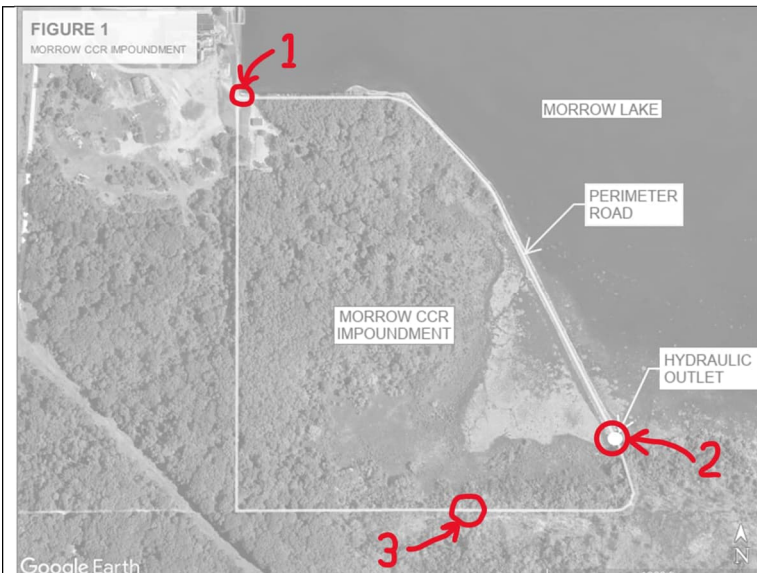
1. Several small trees and tall grasses were observed on both the inboard and outboard slopes of the perimeter dike along the north and east sides of the CCR Unit where bordering open water (see Photos 3-5). While not a significant concern at present, the trees should be cut down to prevent potential future issues caused by large/woody root systems and the grasses should be mowed somewhat regularly to allow better inspection of the slopes.

2. Wetness observed throughout the site due to it being wet season and recent wet weather, however noted one specific location (see Figure 1 and Photo 11) where water was observed flowing across the perimeter road from a swampy area (south) and into the CCR Unit (north). Some channelization observed but no significant erosion otherwise. Continue to observe and consider future project, however no action recommended at this time.

3. Depressions/ruts (see Photos 11-12) caused by vehicle tire tracks in multiple locations around perimeter, particularly along south and west perimeter, and by water flowing across road as noted above, the latter may also be a result of animal activity. Periodic maintenance of roadway recommended.

4. Deteriorating/cracking concrete (see Figure 1 and Photo 7) along inboard slope adjacent to the outlet structure does not appear to pose any immediate issue, however this area should continue to be monitored.

1. Water levels between the CCR Unit and Morrow Lake are in relative equilibrium with little to no flow observed passing through the outlet structure. This is understood to be the normal condition.
2. Debris buildup (see Figure 1 and Photos 6-7 and 9) at both the inlet and outlet ends of the outlet structure should be cleared regularly to remove obstructions to flow and allow for better inspections.

1. Soil covering riprap on outboard slope in NW corner
2. Hydraulic Outlet: buildup of vegetative debris around trash guard/riser structure and in outlet channel to lake and deteriorating concrete along slope between structure and perimeter road.
3. Water observed flowing across the perimeter road and into the CCR Unit.

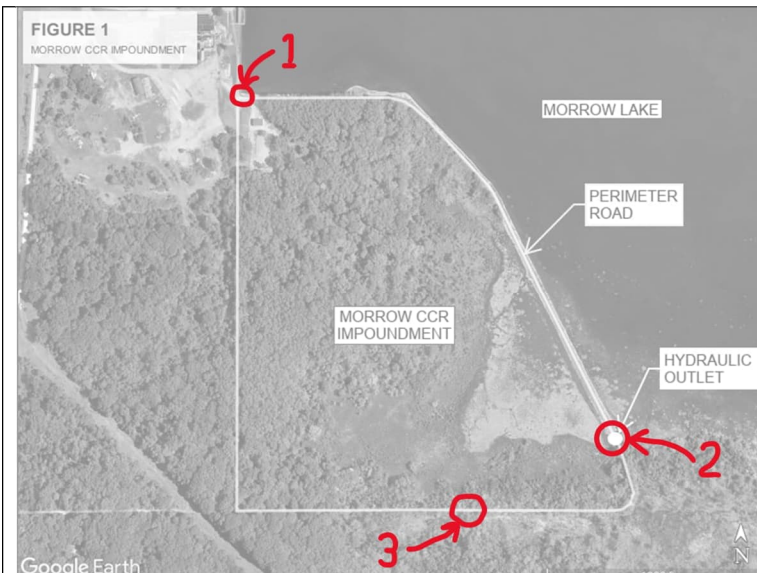
1. A number of small trees and shrubs were observed on both the inboard and outboard slopes of the perimeter dike along the north and east sides of the CCR Unit bordering open water (see Photos 2-5). While not a significant concern at present, the trees should be cut down to prevent potential future issues caused by large/woody root systems and any grasses/reeds growing on slopes should continue to be maintained somewhat regularly to allow better inspection of the slopes.

2. Wetness observed throughout the site due to it being wet season and recent wet/snowy weather, however noted one specific location (see Figure 1 and Photo 11) where water was observed ponding on perimeter road. This implies the possibility of water to flow across the perimeter road from a swampy area (south) into the CCR Unit (north) under suitable conditions. Some channelization observed but no significant erosion otherwise. Continue to observe and consider future repair project, however no action recommended at this time.

3. Depressions/ruts (see Photos 11-12) caused by vehicle tire tracks in multiple locations around perimeter, particularly along south and west perimeter, and by water flowing across road as noted above, the latter may also be a result of animal activity. Periodic maintenance of roadway recommended.

4. Deteriorating/cracking concrete (see Figure 1 and Photo 7) along inboard slope adjacent to the outlet structure does not appear to pose any immediate issue, however this area should continue to be monitored.

1. Water levels between the CCR Unit and Morrow Lake are in relative equilibrium with little to no flow observed passing through the outlet structure. This is understood to be the normal condition.
2. Debris buildup (see Figure 1 and Photos 7, 8, and 9) at both the inlet and outlet ends of the outlet structure should be cleared regularly to remove obstructions to flow and allow for better inspections.

1. Soil covering riprap on outboard slope in NW corner
2. Hydraulic Outlet: buildup of vegetative debris around trash guard/riser structure and in outlet channel to lake and deteriorating concrete along slope between structure and perimeter road.
3. Water observed ponding on perimeter road. Condition implies possibility of flow across the perimeter road and into the CCR Unit under suitable conditions.

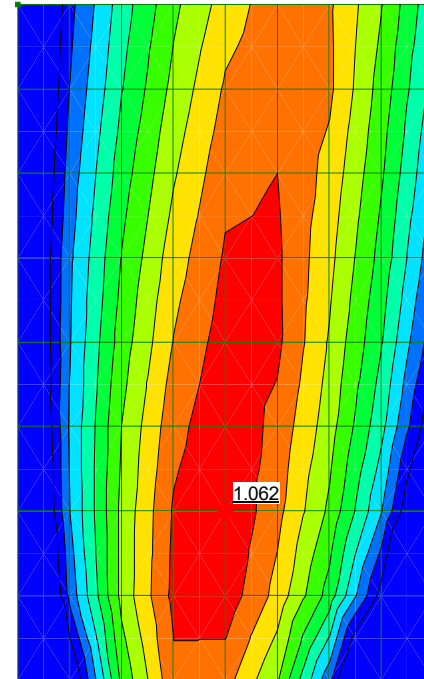
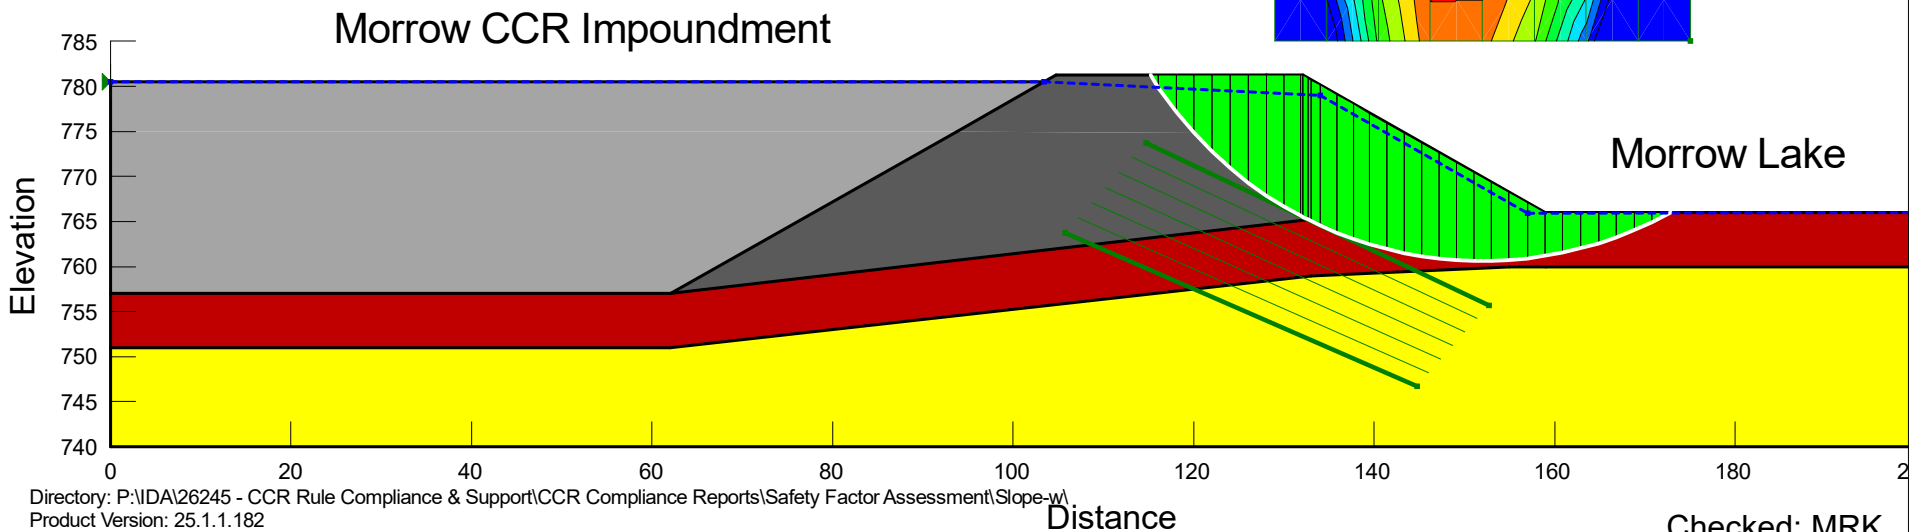
Structural Stability Assessment - Morrow Impoundment
 Analysis: Deep Static Rapid Drawdown Rotational Dike Failure
 Created By: KEY Environmental
 Date: 05/06/2026
 Factor of Safety: 1.062
 Horz Seismic Coef.: g

In this analysis, it was conservatively assumed that the Morrow Lake elevation was ± 779 feet when the rapid drawdown event occurred. Using this conservative assumption, the calculated rapid drawdown factor of safety for the Impoundment is 1.06 which suggests the unit would maintain its structural stability under this condition. The rapid drawdown analysis result is included as Attachment 3.
